# Manhole Inspection Summary

Manhole # S41A2\_009MH

Insp Date: **4/24/08 1:41 PM**

**Location** Address: **3709 8th St.**

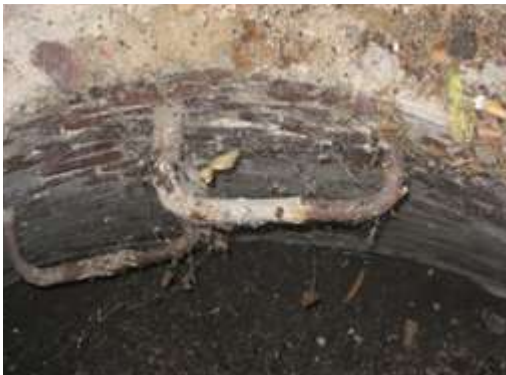
Count: **2** Missing: **0** ☒ **Corroded**

steps

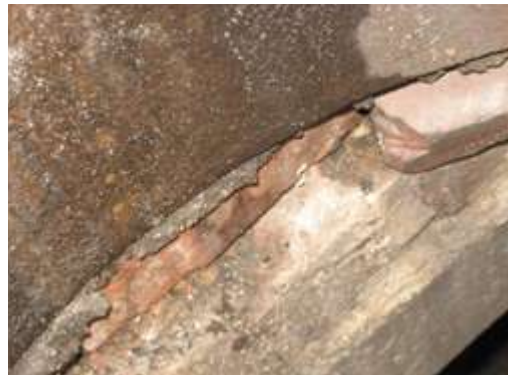
Defect 1

Condition: ☐ Sound ☐ Cracked ☐ Root Intrusion ☒ **Loose Brick** ☐ Deteriorated

loose bricks

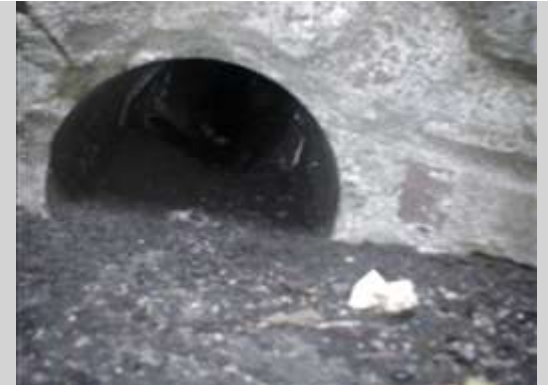
12 O'Clock Outflow

8 in. Circular Gravity Sewer  
Pipe Out @ 12 O'Clock

Infiltration: **None** Pipe Seal Cond: **Sound**
